March 7, 2024

## **Sept. 11, 2023, downtown power outage and underground fire**

### **Executive Summary**

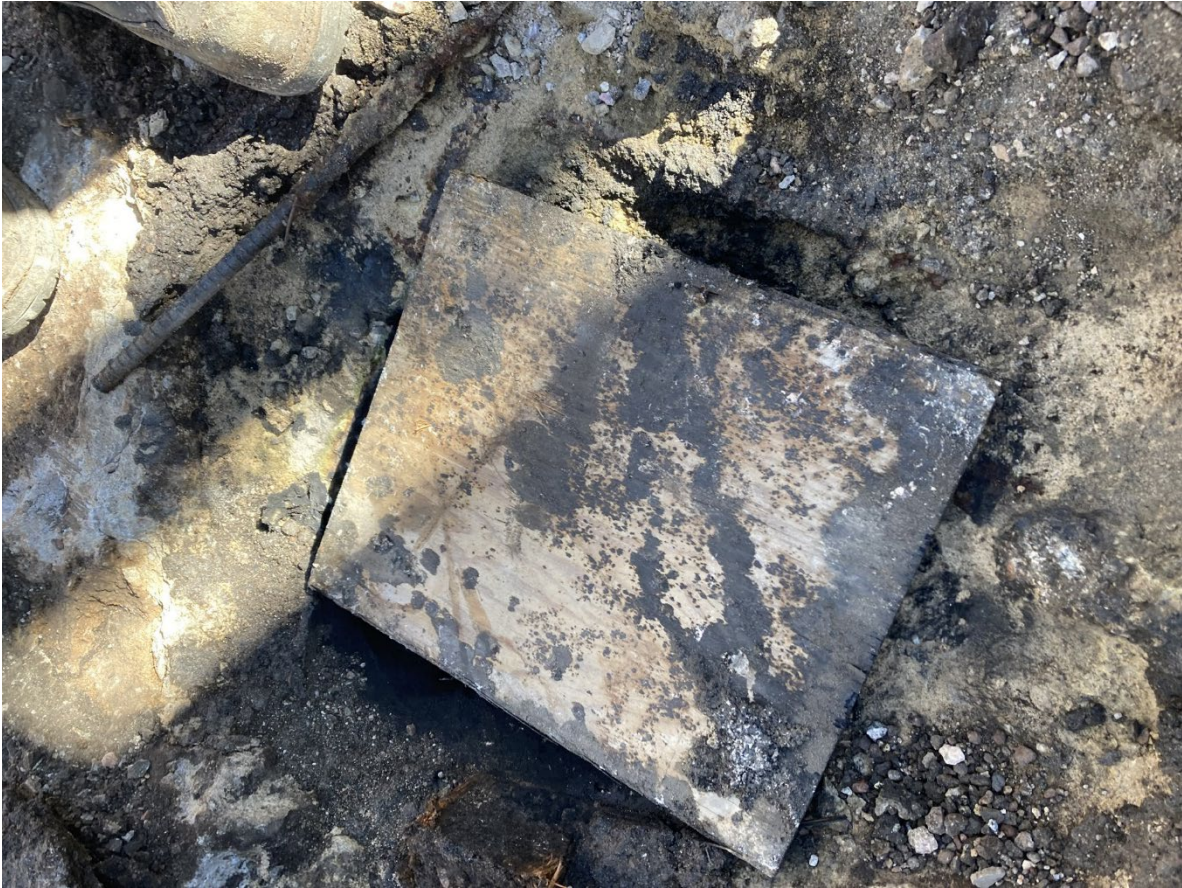
One of the sites revealed a makeshift plywood patch (**Photo 1**), under which was extensive damage (**Photos 2 and 3**). This is the most likely point of origin for the fire.

**Photo 1 – Plywood patch**

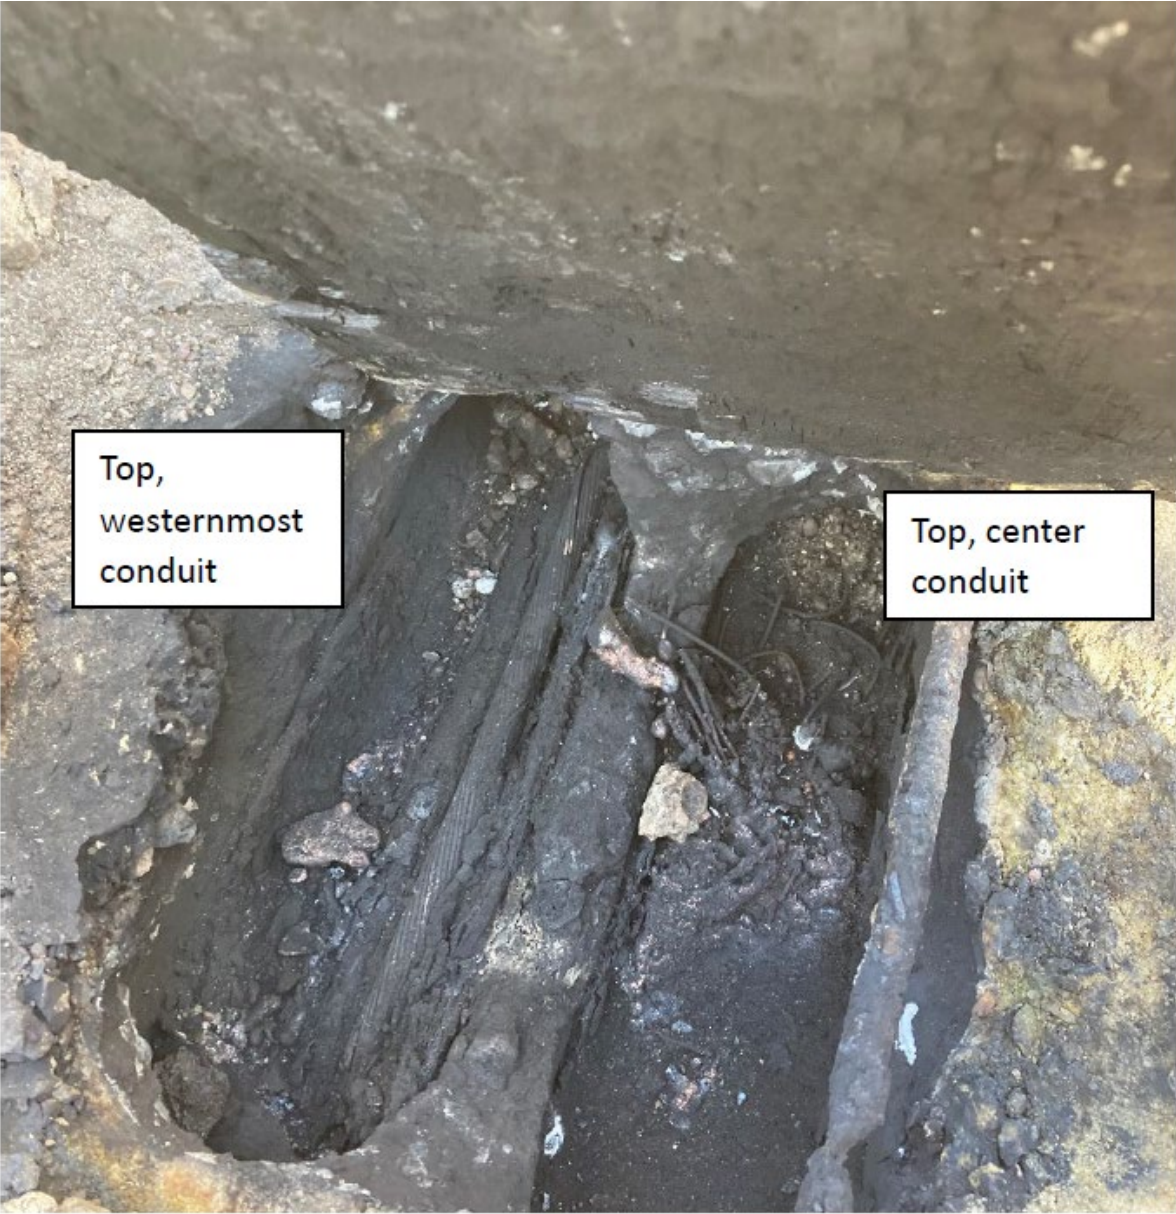
As part of the investigation and restoration efforts, an excavation was conducted underneath the affected portion of Kiowa Street. This excavation revealed three potential origins for the fire based on large quantities of melted copper, disintegrated cable and melted rebar. At least one site showed clear evidence of damage consistent with core drilling operations, which are often conducted by contractors using a truck-mounted drill as part of a process to install underground wire or conduit.

Photo 2 – Damage underneath plywood patch

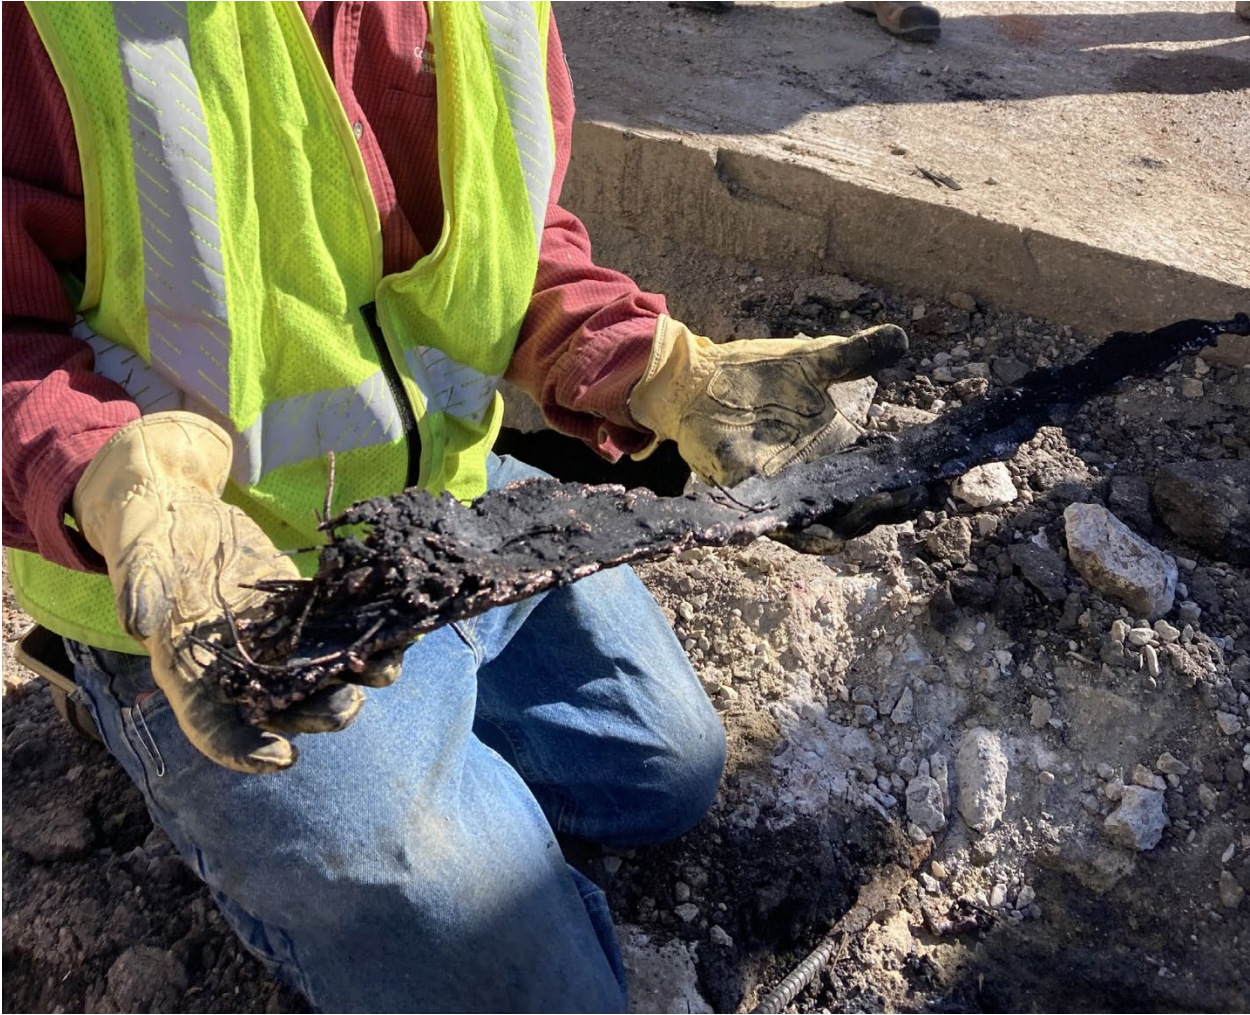
If just one or two electric cables suffer minor damage, like a nick in the insulation from a core drilling incident, it could lead to equipment failure over time. When an underground electric cable is damaged, energy doesn't flow correctly through it causing an "energy leak." Should additional cables sustain damage, the subsequent chain of events could result in a catastrophic failure.

**Photo 3 – Damaged cable underneath plywood patch**

Colorado Springs Utilities is pursuing new technology on its underground cables to isolate damaged electric cables from the rest of the system. This emerging technology could limit large-scale damage like what occurred on Sept. 11, 2023.

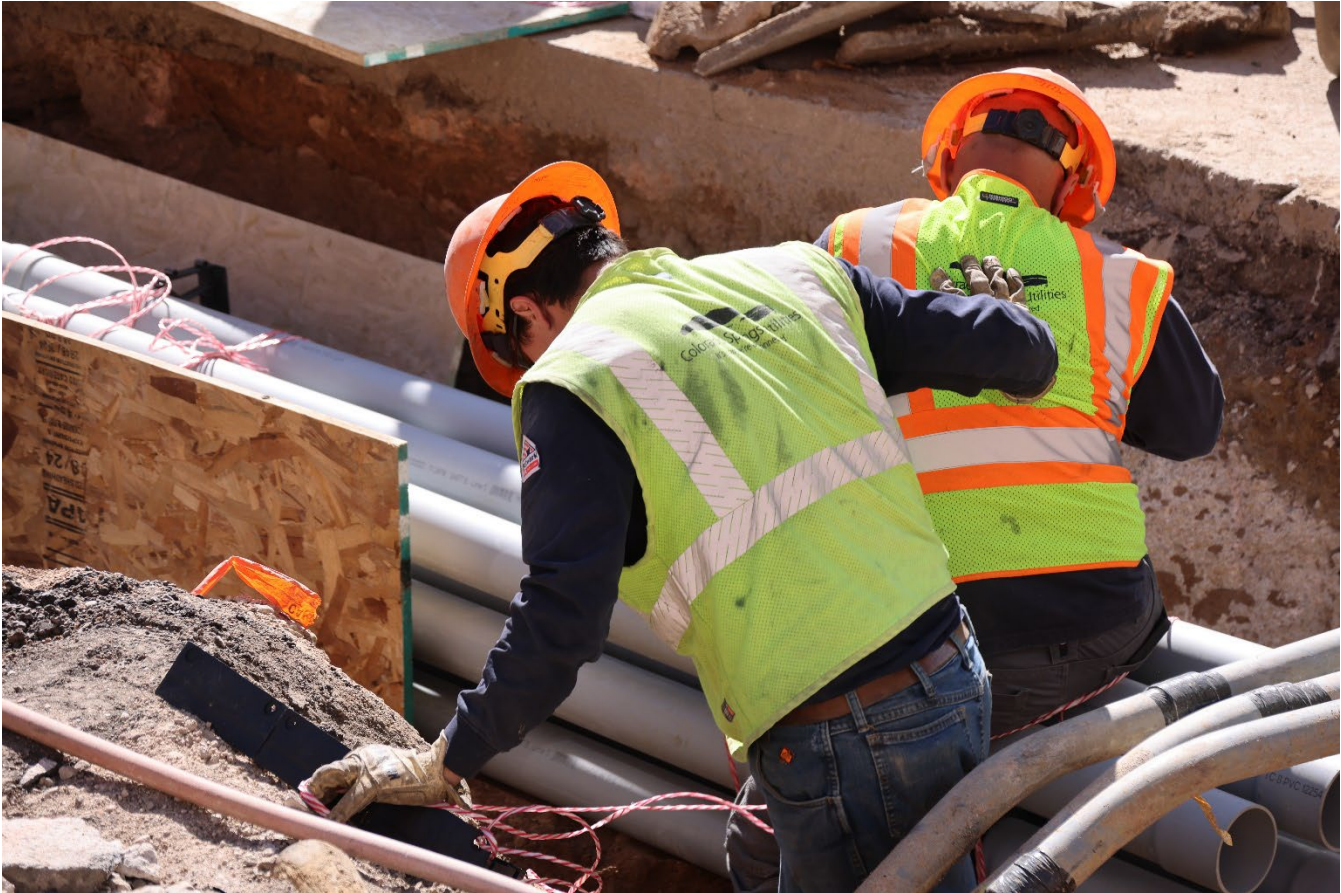
Photo 4 – Example of new underground conduit
