January 9, 2017

Re: Coal Combustion Residual (CCR) Landfill Annual (2016) Inspection
Clear Springs Ranch
Fountain, Colorado
Terracon Project No. 23155030

PHOTOGRAPH LOCATION DIAGRAM
 CCR LANDFILL ANNUAL (2016) INSPECTION
 CLEAR SPRINGS RANCH
 FOUNTAIN, COLORADO

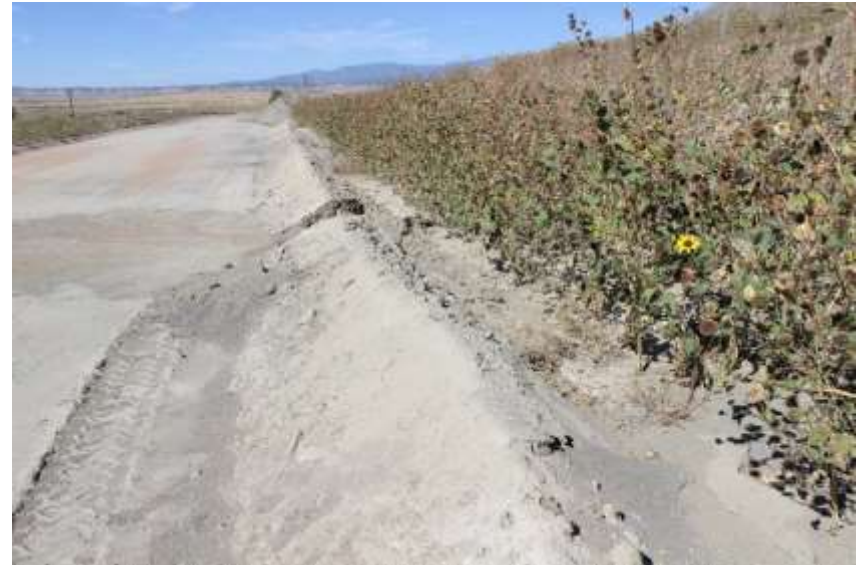
Photo #34

The perimeter earthen road at the toe of the landfill slopes generally had loose soil berms on the upslope and downslope edges of the roadway. The upslope roadway berm had one, approximate 2-foot wide erosion channel along the south face near the southwest corner of the landfill (See Photos #33 to #35). In addition, the slope below the fill terrace along the eastern boundary (see Photograph Location Diagram #78 and #79 for location) has loader wheel ruts that have exposed the underlying ash.

We recommended to UTILITIES representatives that slopes with erosion features (gullies) greater than about 3 to 6 inches deep be filled and re-graded. We understand the grading activities are typically accomplished by tracking a bulldozer up and down the slopes. In addition, we recommended the soil berms adjacent to roadways be repaired as necessary for continuity and the loader wheel ruts along the eastern boundary be filled in.

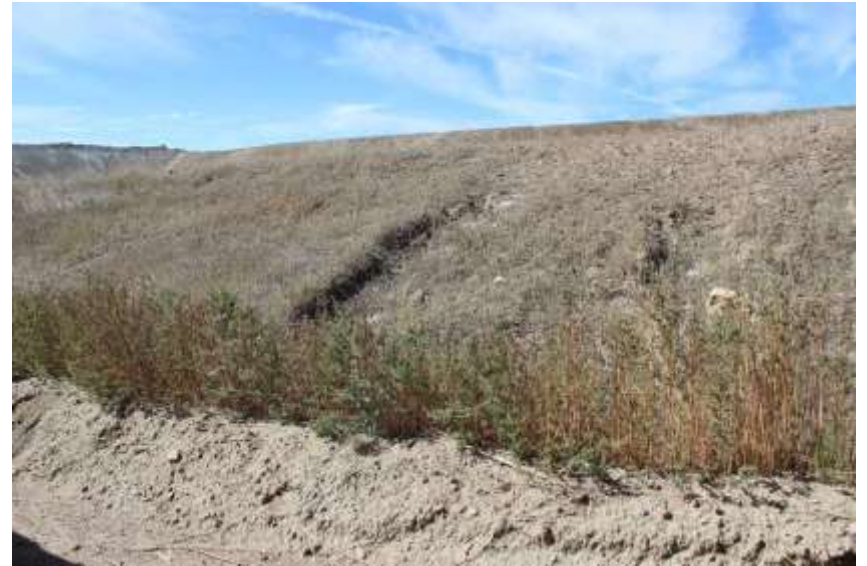
Photo #78

During our subsequent site visit on December 21, 2016, the observed exposed flyash within the frontend loader wheel ruts had been repaired (See Photos #81 and #82). The erosion channel within the upslope roadway berm (Photos #78 and #79) was repaired (see Photos #86 and #87). The erosion gullies observed at within the slopes at the southwest corner of the landfill, as well as other areas of the landfill had also been regraded, covering the erosion features (See Photos #83 through #85, and #88 through 90).
