January 9, 2017

Re: Coal Combustion Residual (CCR) Landfill Annual (2016) Inspection
Clear Springs Ranch
Fountain, Colorado
Terracon Project No. 23155030

PHOTOGRAPH LOCATION DIAGRAM
 CCR LANDFILL ANNUAL (2016) INSPECTION
 CLEAR SPRINGS RANCH
 FOUNTAIN, COLORADO

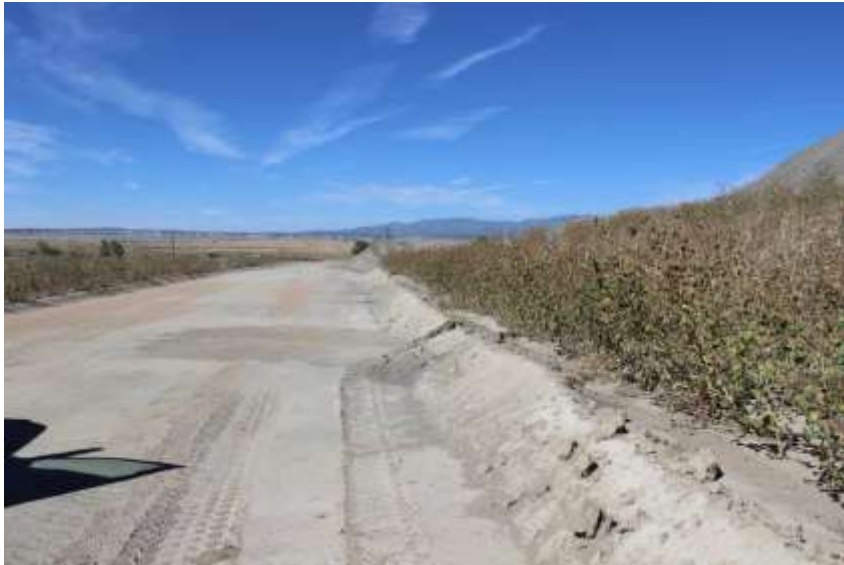
Photo #33

The perimeter earthen road at the toe of the landfill slopes generally had loose soil berms on the upslope and downslope edges of the roadway. The upslope roadway berm had one, approximate 2-foot wide erosion channel along the south face near the southwest corner of the landfill (See Photos #33 to #35). In addition, the slope below the fill terrace along the eastern boundary (see Photograph Location Diagram #78 and #79 for location) has loader wheel ruts that have exposed the underlying ash.

We recommended to UTILITIES representatives that slopes with erosion features (gullies) greater than about 3 to 6 inches deep be filled and re-graded. We understand the grading activities are typically accomplished by tracking a bulldozer up and down the slopes. In addition, we recommended the soil berms adjacent to roadways be repaired as necessary for continuity and the loader wheel ruts along the eastern boundary be filled in.
