Re: Coal Combustion Residual (CCR) Landfill Annual (2015) Inspection & Qualified Personnel Training
Clear Springs Ranch
Fountain, Colorado
Terracon Project No. 23155030

PHOTOGRAPH LOCATION DIAGRAM
 CCR LANDFILL ANNUAL INSPECTION
 CLEAR SPRINGS RANCH
 FOUNTAIN, COLORADO

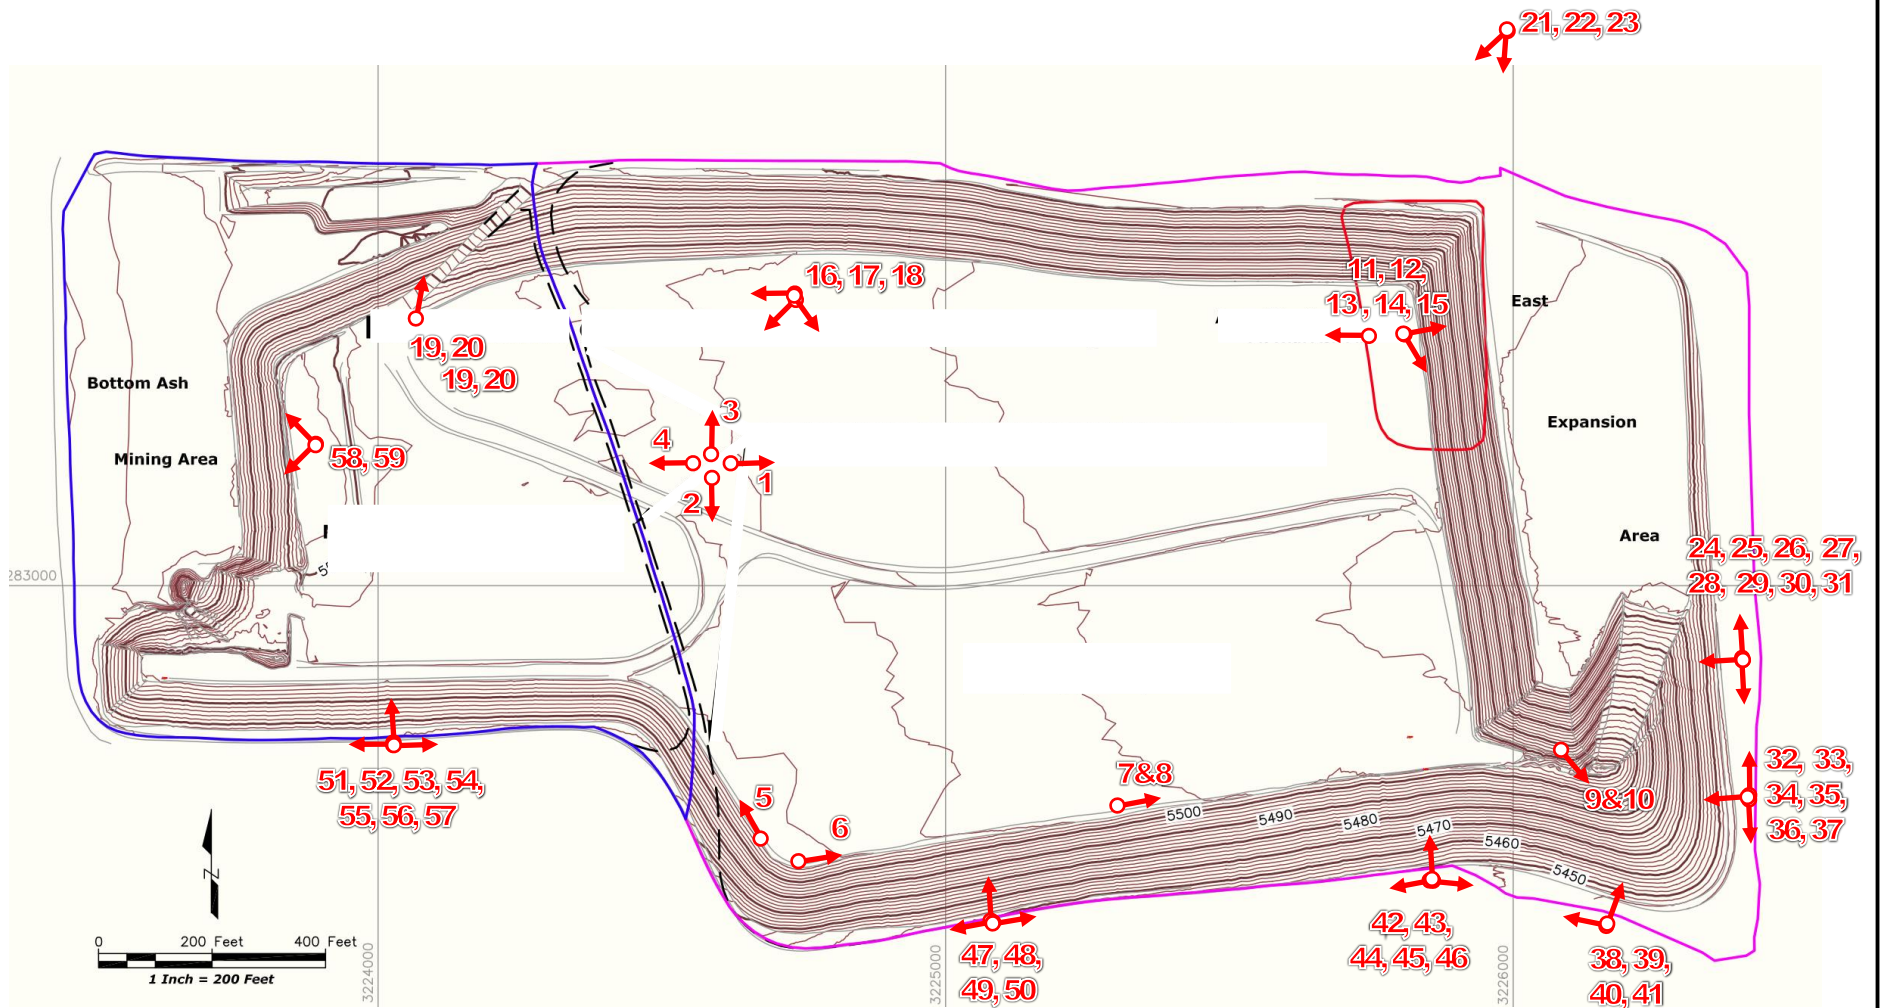
Exhibit
A-1

INDICATES PHOTO NUMBER AND ORIENTATION

BASE DRAWING OBTAINED FROM THE CSU 2014 SURVY DRAWING, DATED DECEMBER 23, 2014
 DIAGRAM IS FOR GENERAL LOCATION ONLY, AND IS NOT INTENDED FOR CONSTRUCTION PURPOSES
