Subject: Geologic Hazards Evaluation

Project: Proposed Colorado Springs Utilities Skyway Pump Station Site

Location: Parcel #6506300005, Southwest Corner of Star Ranch Road and Broadmoor Valley Road, Colorado Springs, Colorado

Project No: D24-2-754

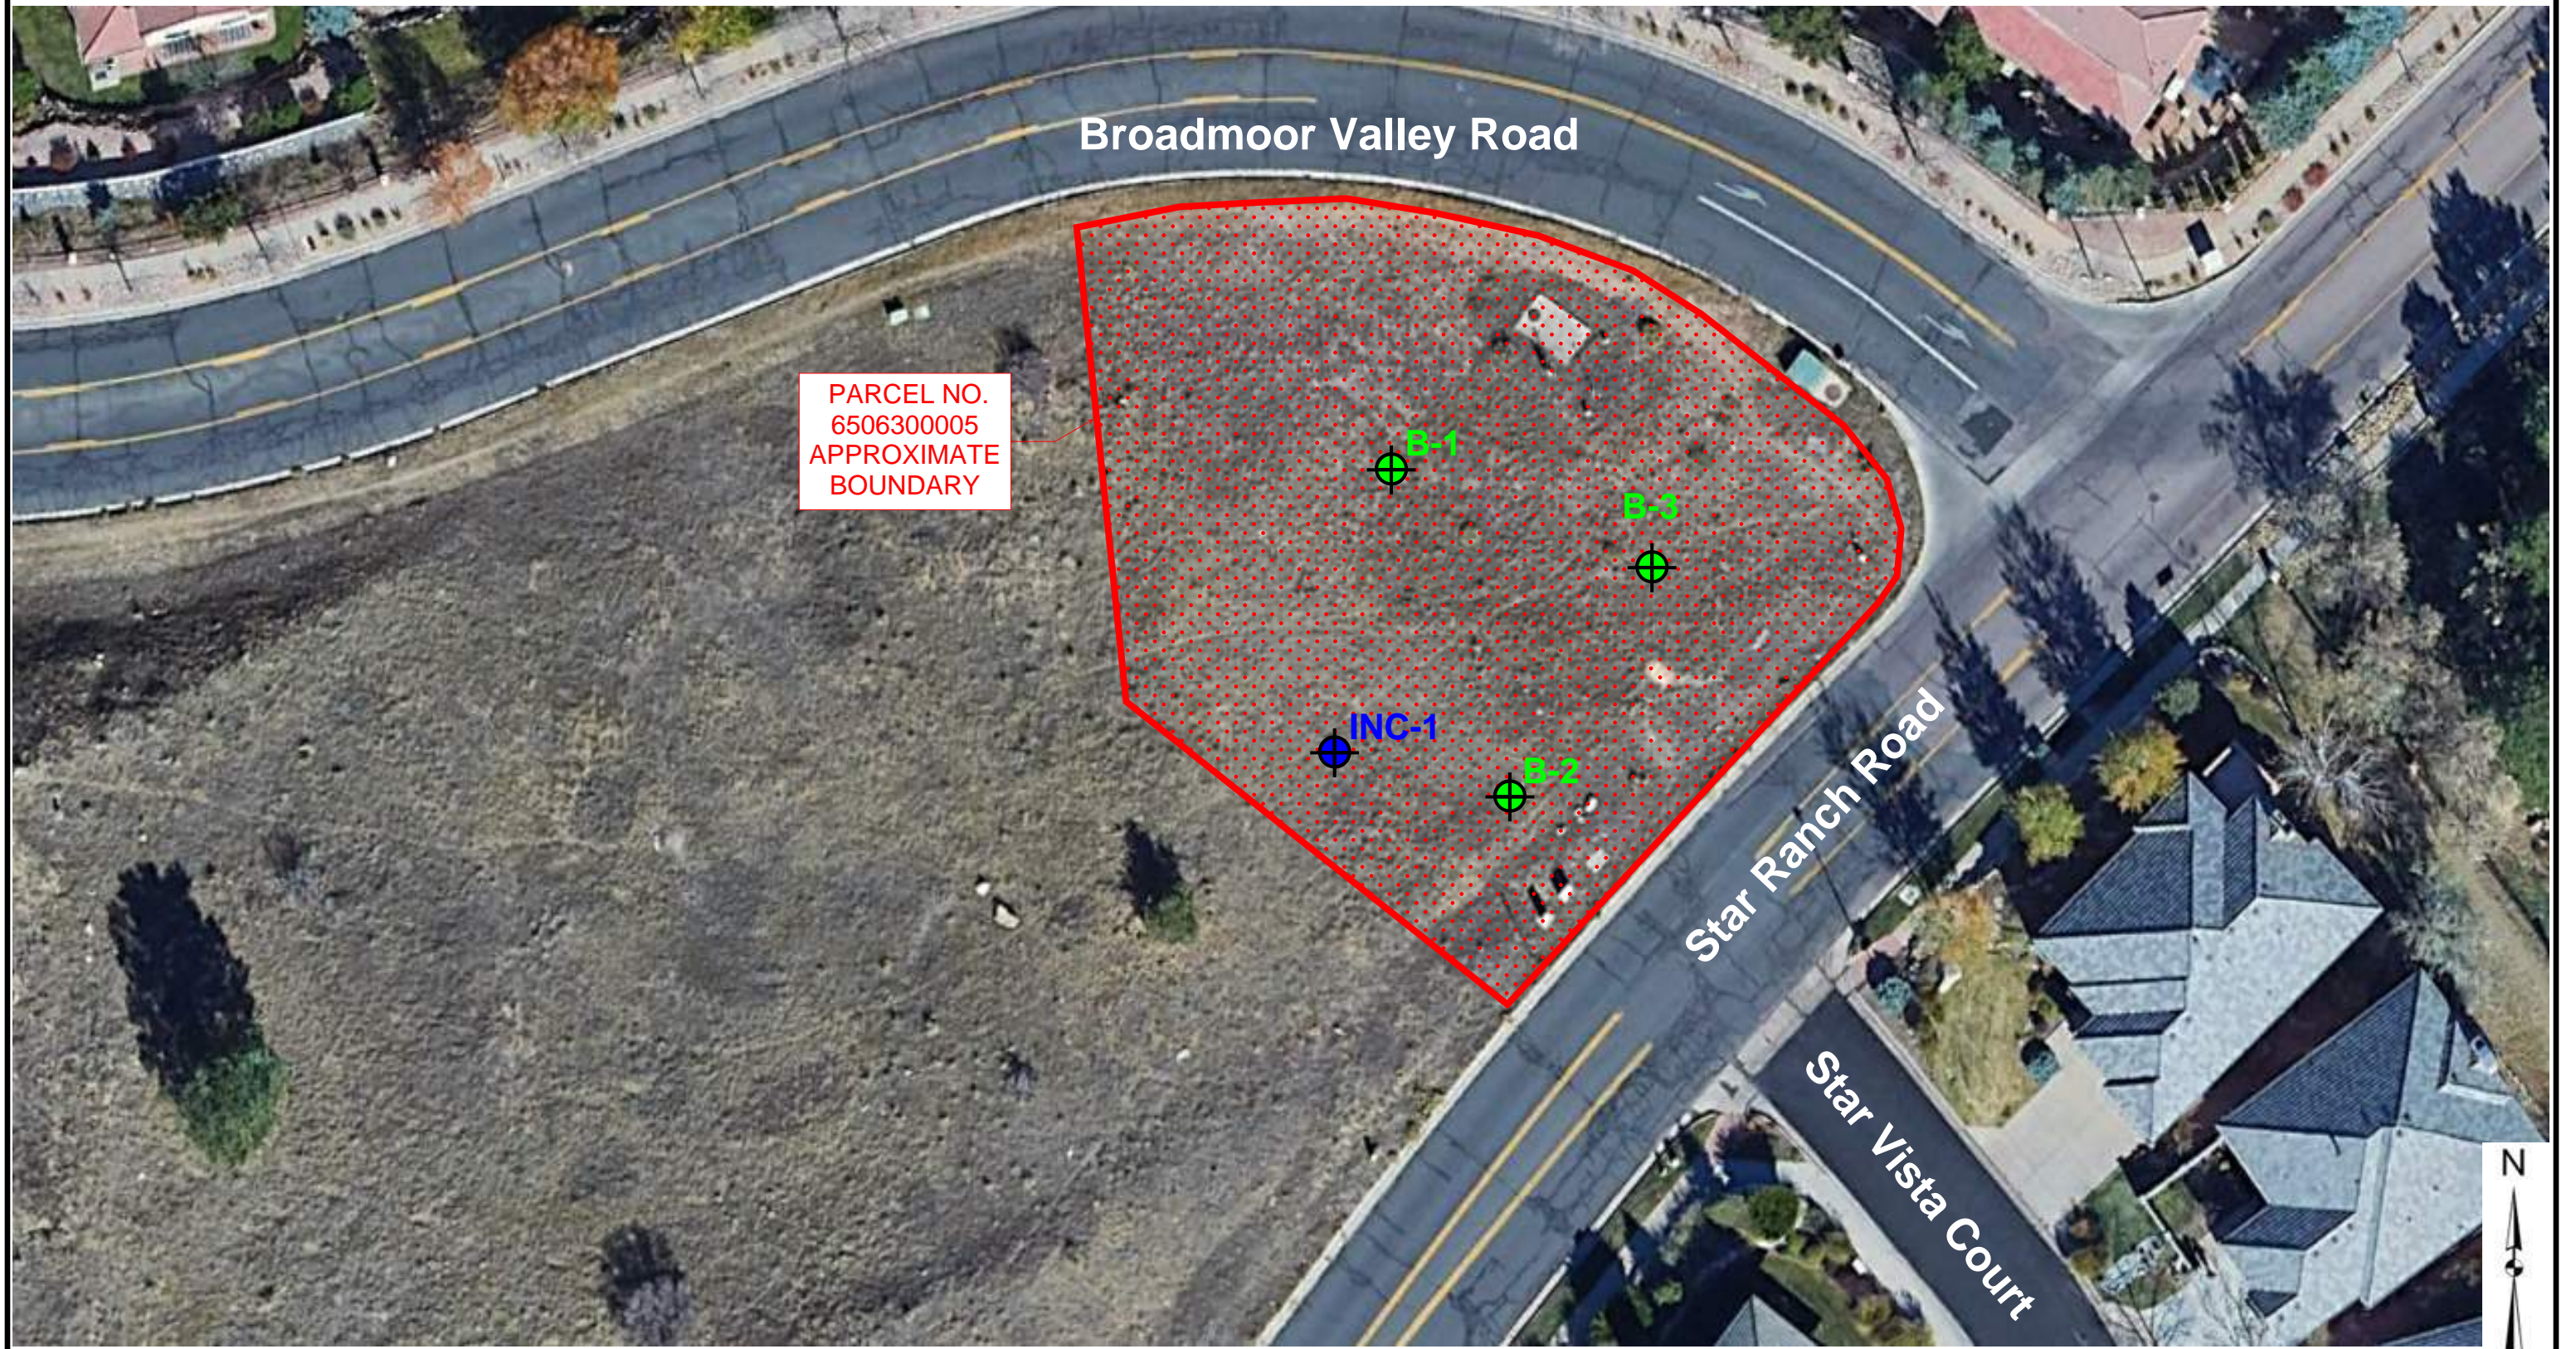
PARCEL NO.
6506300005
APPROXIMATE
BOUNDARY

- Application Form for Geologic Hazard Report
- Figure 1 – Vicinity Map
- Figure 2.1 – Field Exploration Plan
- Figure 2.2 – Geologic Map
- Figure 2.3 – Landslide Boundary Overlay

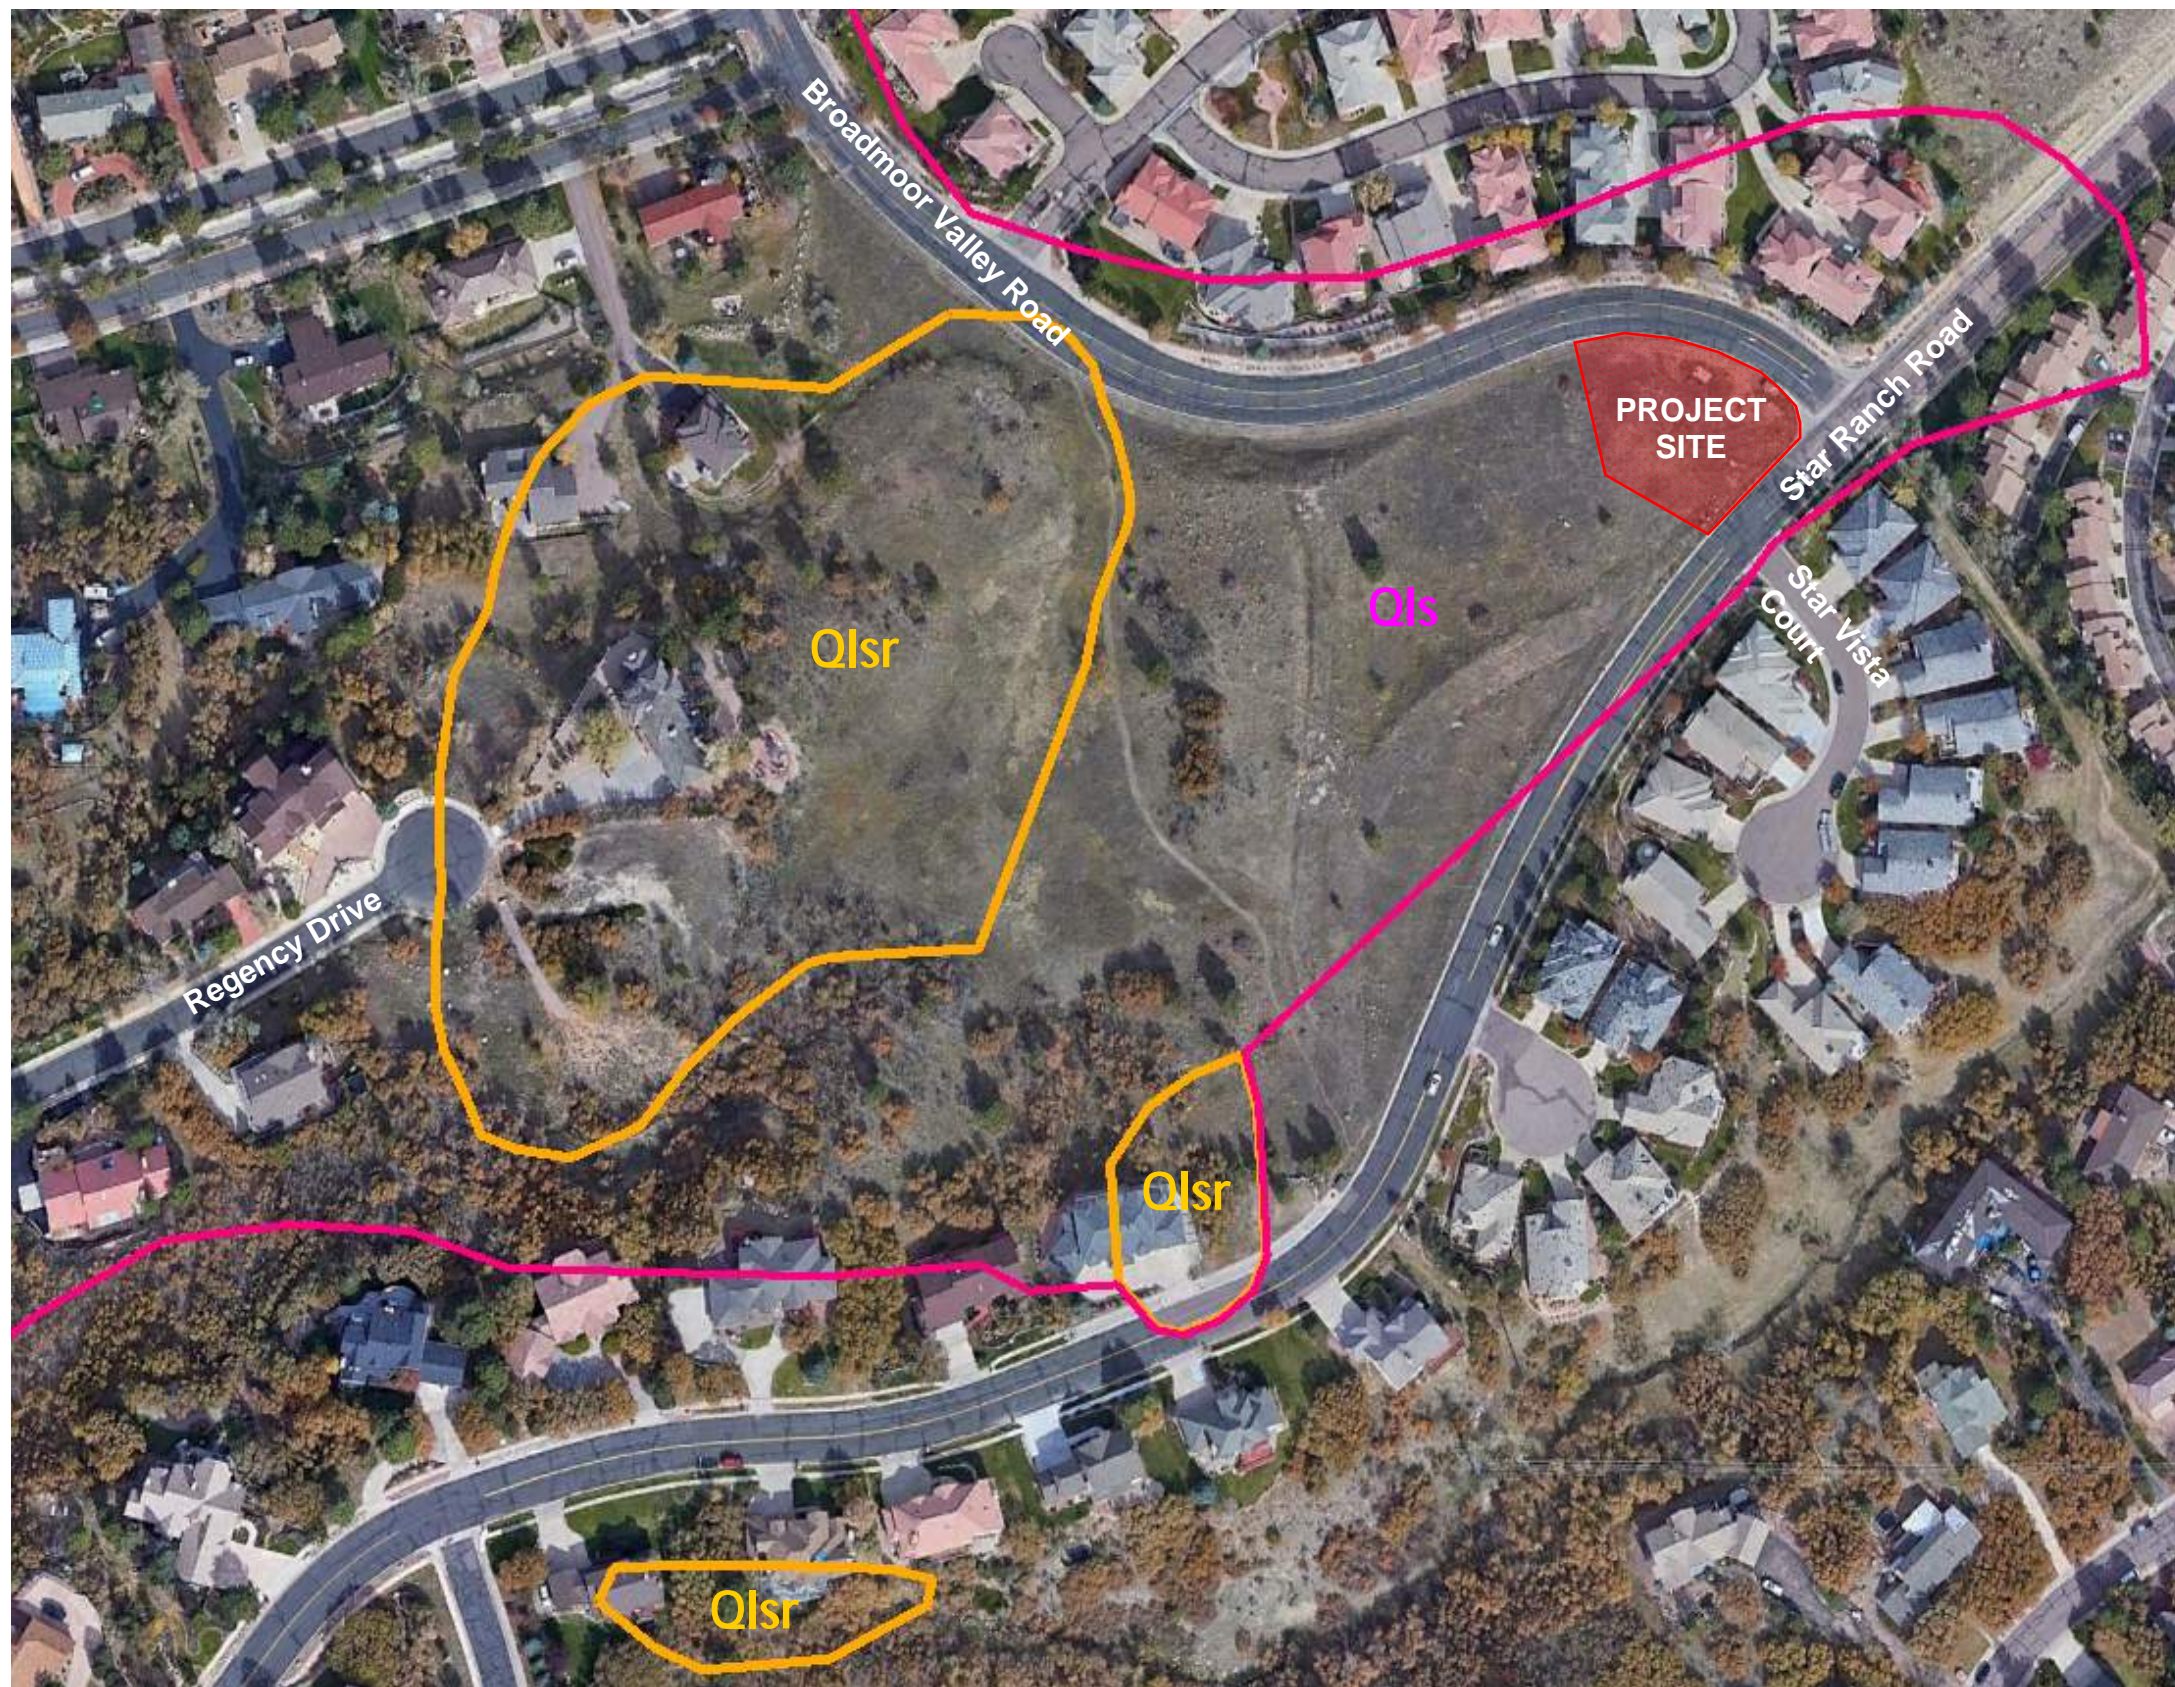
NOTES:
 LANDSLIDE BOUNDARIES
 ARE APPROXIMATE AND
 ESTIMATED FROM
 GEOLOGIC MAP OF
 COLORADO SPRINGS
 QUADRANGLE PRESENTED
 ON FIGURE 2.2

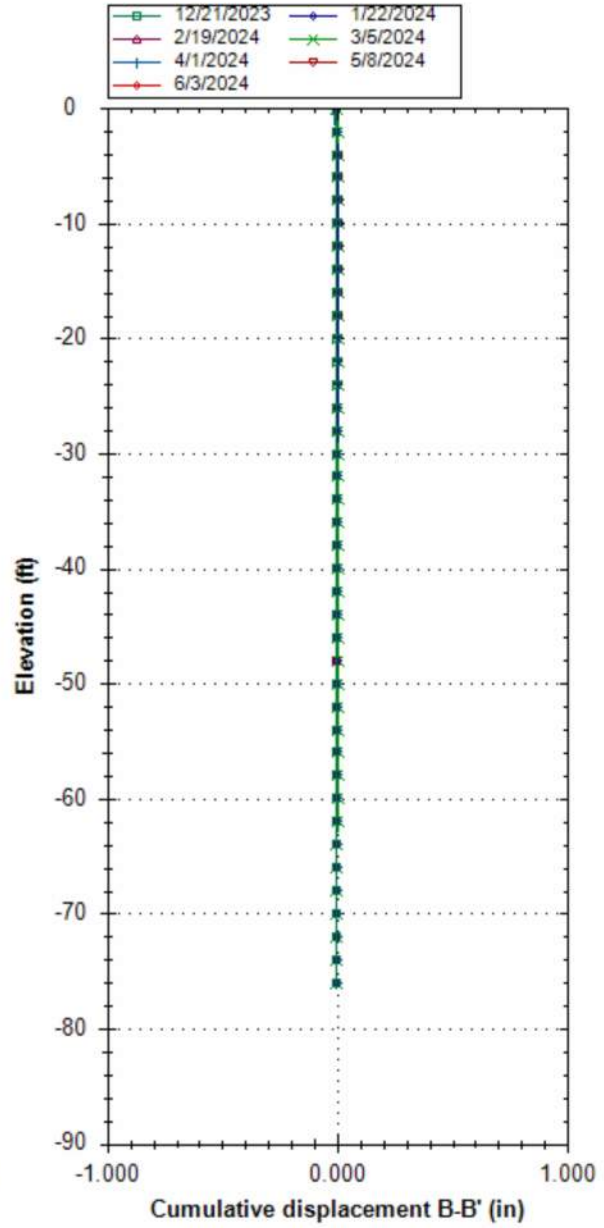
INC-1

Inst. date:
Top elevation: 0
Bottom elevation: -76
Alpha (deg): 0
Last reading: 6/3/2024 9:52:00 AM
Cumulative A+: 0, A-: 0
Cumulative B+: 0, B-: -0.01

- Continue to monitor the inclinometer that has been installed uphill of the site for landslide-related movement, including monitoring during construction and foundation excavations.

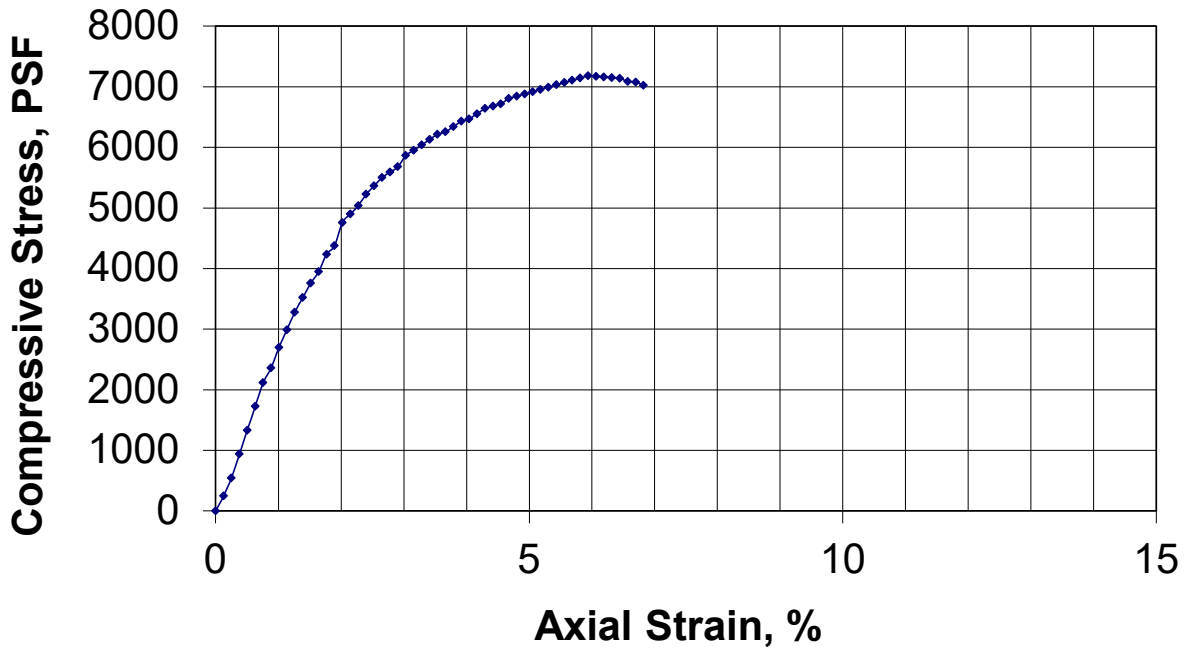
Stress - Strain Curve

UNCONFINED COMPRESSION TEST ASTM D 2166

DESCRIPTION: Sandy Fat CLAY, brown, moist

Avg. Height, In.: 3.957
 Avg. Diameter, In.: 1.923
 L/D Ratio: 2.1
 Moisture Content, %:
 (Sample, After test) 21.3
 Dry Density, pcf: 106.1
 Assumed Specific Gravity: 2.7
 Saturation, %: 97.9
 Void Ratio: 0.588

PSF	PSI
Compressive Strength @ Failure:	7179	50
Shear Strength @ Failure:	3590	25
Axial Strain @ Failure, %:	5.9	5.9

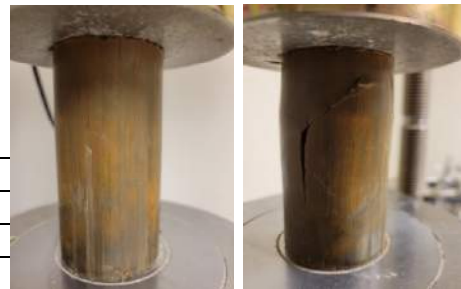
Stress - Strain Curve

UNCONFINED COMPRESSION TEST ASTM D 2166

DESCRIPTION: Weathered CLAYSTONE, brown moist

Avg. Height, In.: 3.910
 Avg. Diameter, In.: 1.930
 L/D Ratio: 2.0
 Moisture Content, %:
 (Sample, After test) 17.1
 Dry Density, pcf: 115.8
 Assumed Specific Gravity: 2.7
 Saturation, %: 101.3
 Void Ratio: 0.454
 Rate of Strain, %/Minute: 1.0

PSF	PSI
Compressive Strength @ Failure:	12704	88
Shear Strength @ Failure:	6352	44
Axial Strain @ Failure, %:	7.2	7.2

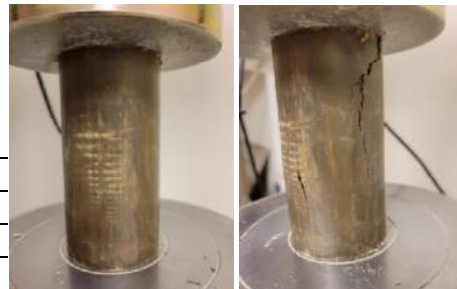
Photo:

UNCONFINED COMPRESSION TEST ASTM D 2166

DESCRIPTION: Sandy Fat CLAY, light brown, moist

Avg. Height, In.: 3.960
 Avg. Diameter, In.: 1.930
 L/D Ratio: 2.1
 Moisture Content, %:
 (Sample, After test) 15.3
 Dry Density, pcf: 116.8
 Assumed Specific Gravity: 2.7
 Saturation, %: 93.3
 Void Ratio: 0.442
 Rate of Strain, %/Minute: 1.0

PSF	PSI
Compressive Strength @ Failure:	15444	107
Shear Strength @ Failure:	7722	54
Axial Strain @ Failure, %:	1.6	1.6
